**AFRL-ML-WP-TR-2007-4145**

**QUICK REACTION EVALUATION OF  
MATERIALS AND PROCESSES**

**Delivery Order 0010: Bonded Boron Patch  
Repair Evaluation**

**Final Report for 01 March 2005 – 01 September 2006**

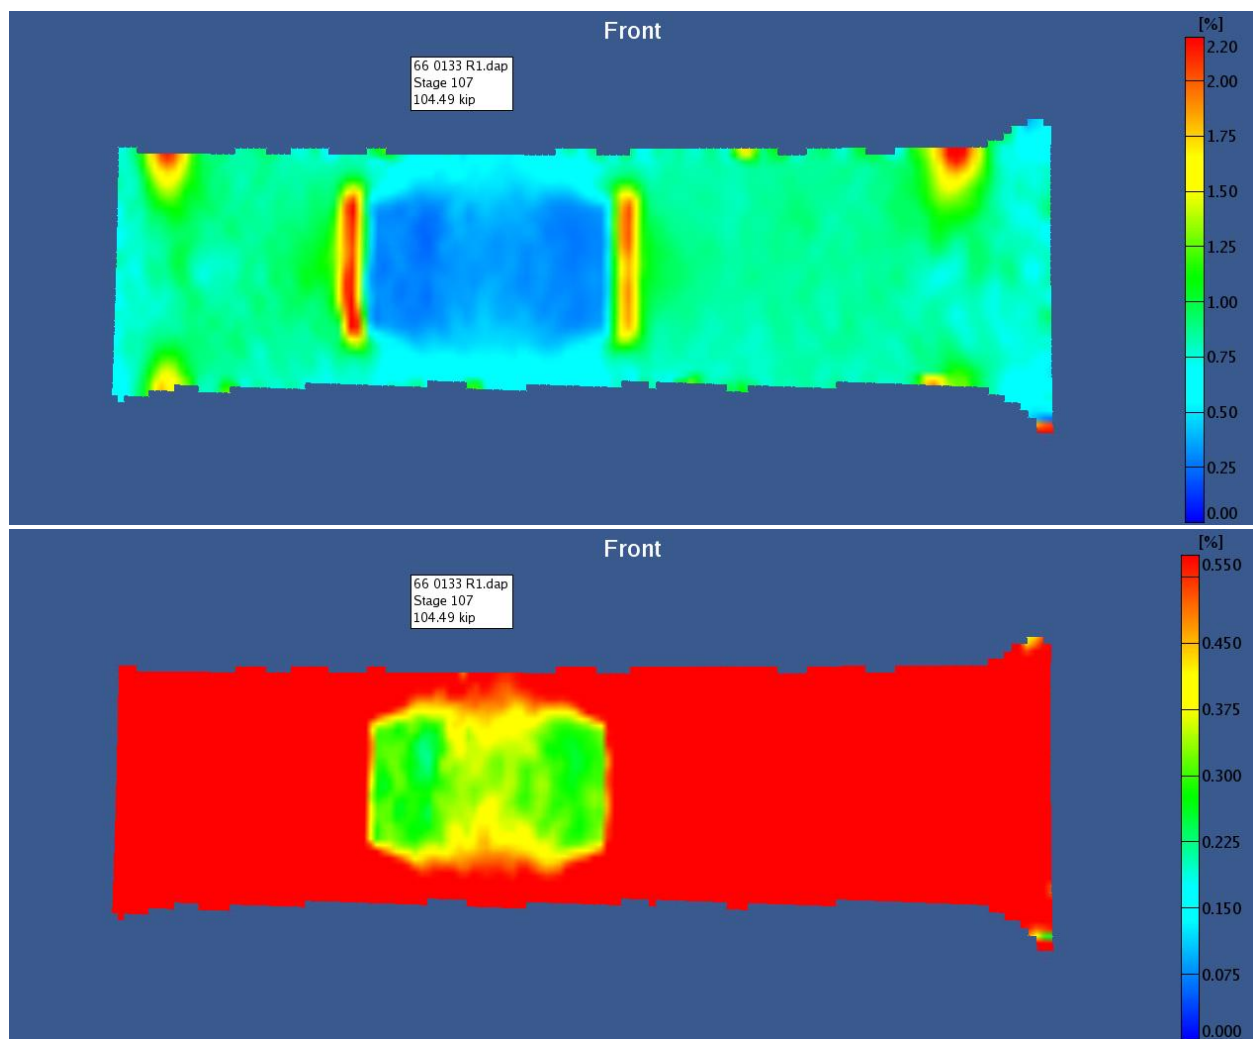
The majority of the original repairs sustained no patch related failures. These specimens generally failed in the gage (reduced) section of the aluminum away from the patch. For these typical cases, the SO results were checked to confirm there were no delaminations or other patch events, and then saved for future use. For brevity, only a representative SO response is presented in this report, rather than listing each individual specimen. Figure 23 displays a typical SO response for an original repair, with the strain scale changed from high to low scale to better illustrate the surface strain through the specimen and the OML patch. In this case, the original repair was a square edge patch design.

**Figure 23. Typical SO Response of Original Repairs (top = high scale, bottom = low scale).**

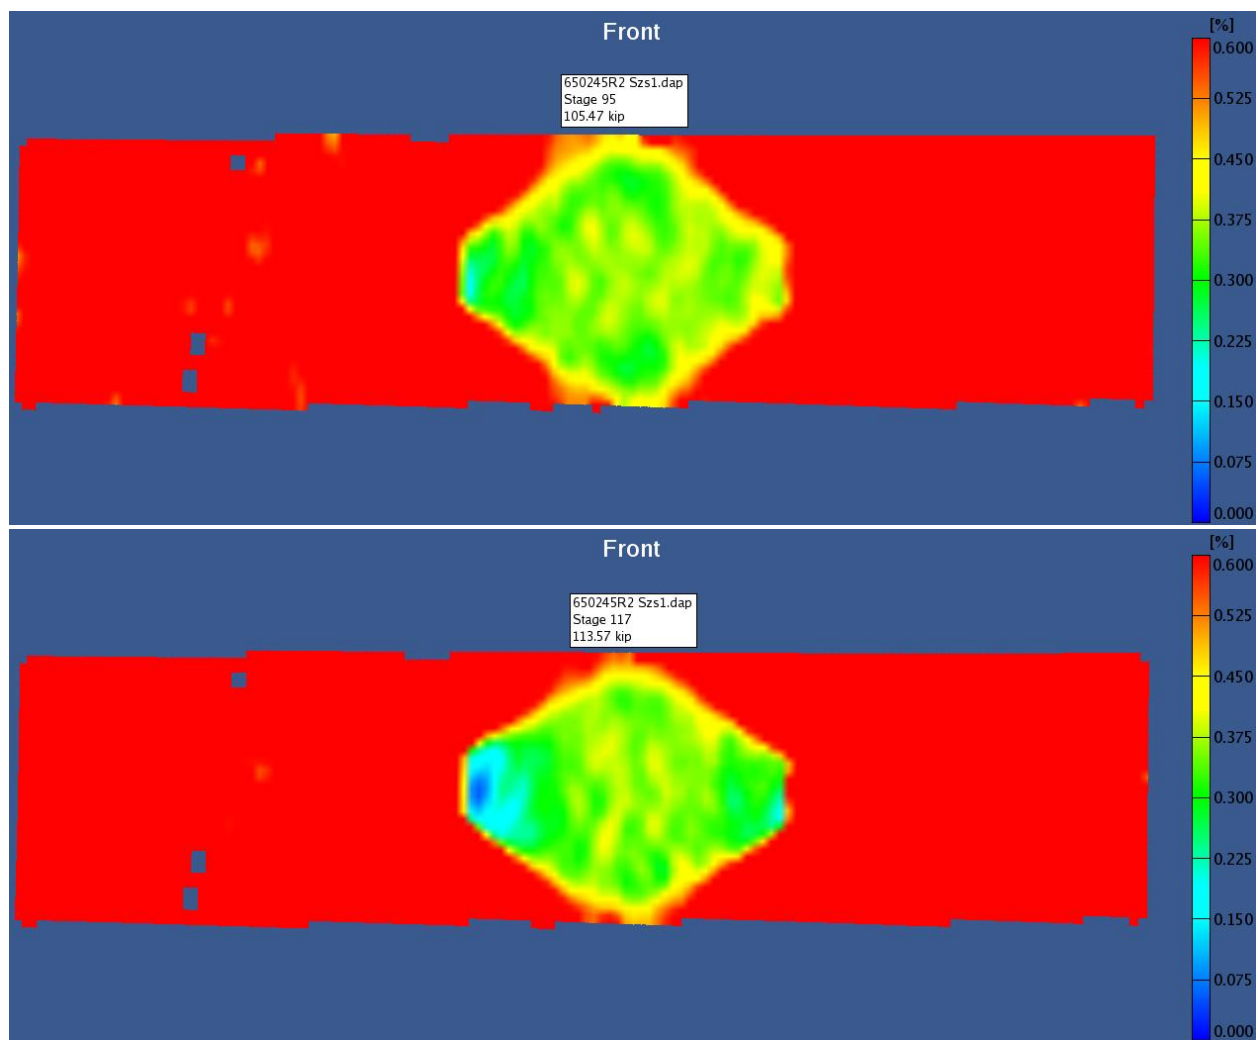
Specimen number 65-0245 R 2 had a patch with a clipped edge, aligned OML patch (TI repair) that began to delaminate at the corner of the patch at approximately 77 ksi. The delamination/disbond grew under increasing load across the edge of the specimen, then increasing in size under the skin with increasing load. The specimen failed at 83.1 ksi. Figure 24 shows the strain field of the patch failure at the first detectable occurrence as well as the final maximum extent of the delamination, just prior to sample failure. Note that the scale used in the figure has been reduced to more clearly show the patch failure. The OML patch became completely disbonded upon failure and separated from the specimen.

**Figure 24. OML Patch Delamination; Repair 65-0245 R 2.**

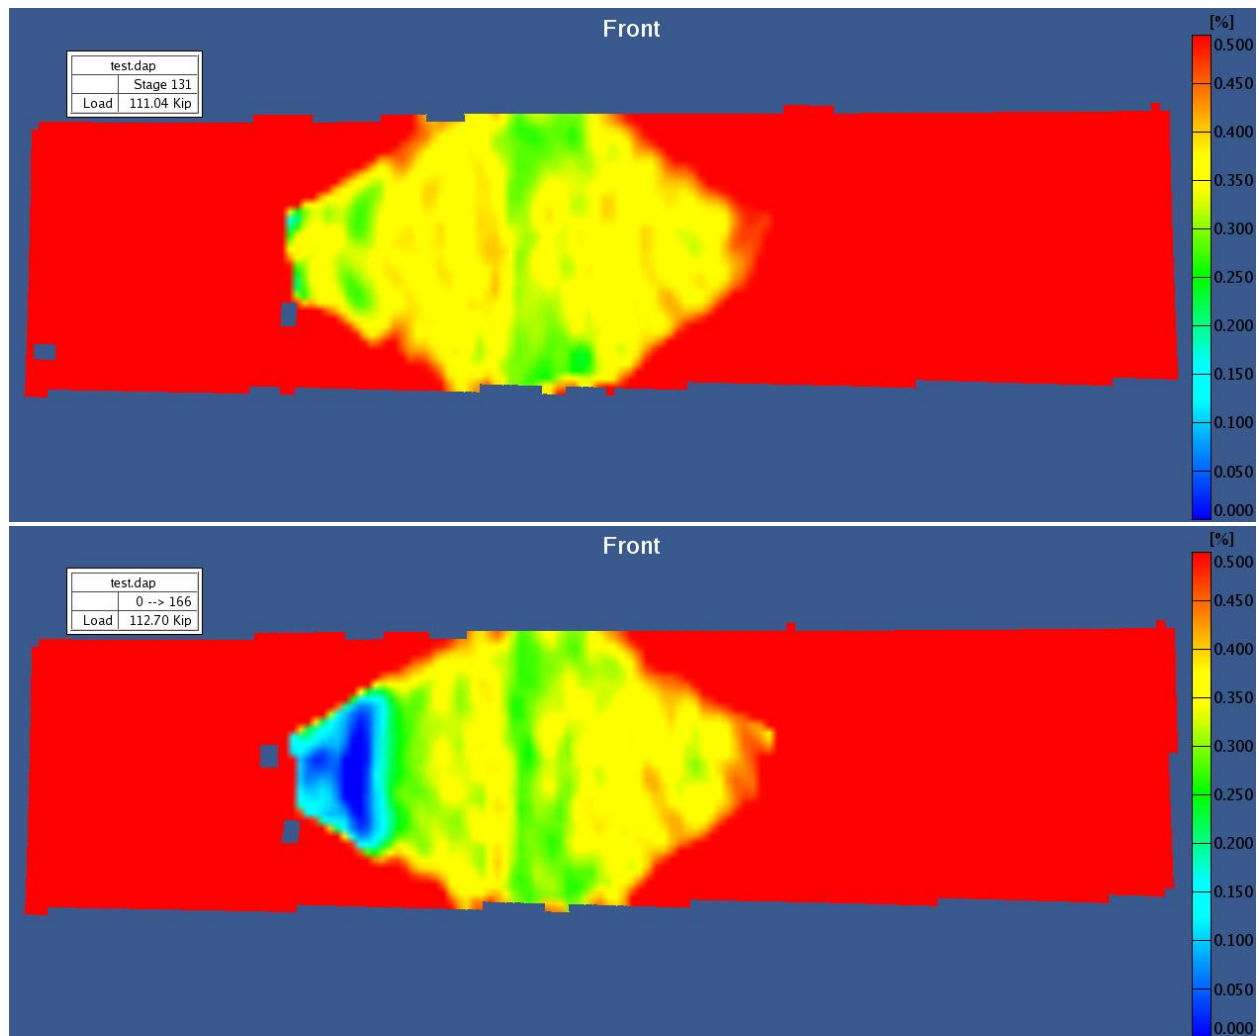
Specimen number 66-0168 R 1 had a clipped edge, aligned OML patch (TI repair) that began to delaminate at the corners of the patch at approximately 84 ksi. The delaminations grew under increasing load across the edge of the specimen, eventually joining into a single delamination and growing under the skin with increasing load. The specimen failed at 86.3 ksi. Figure 25 shows the strain field of the patch failure at first detectable occurrence as well as the final maximum extent of the delamination, just prior to substrate failure.

**Figure 25. OML Patch Delamination; Repair 66-0168 R 1.**

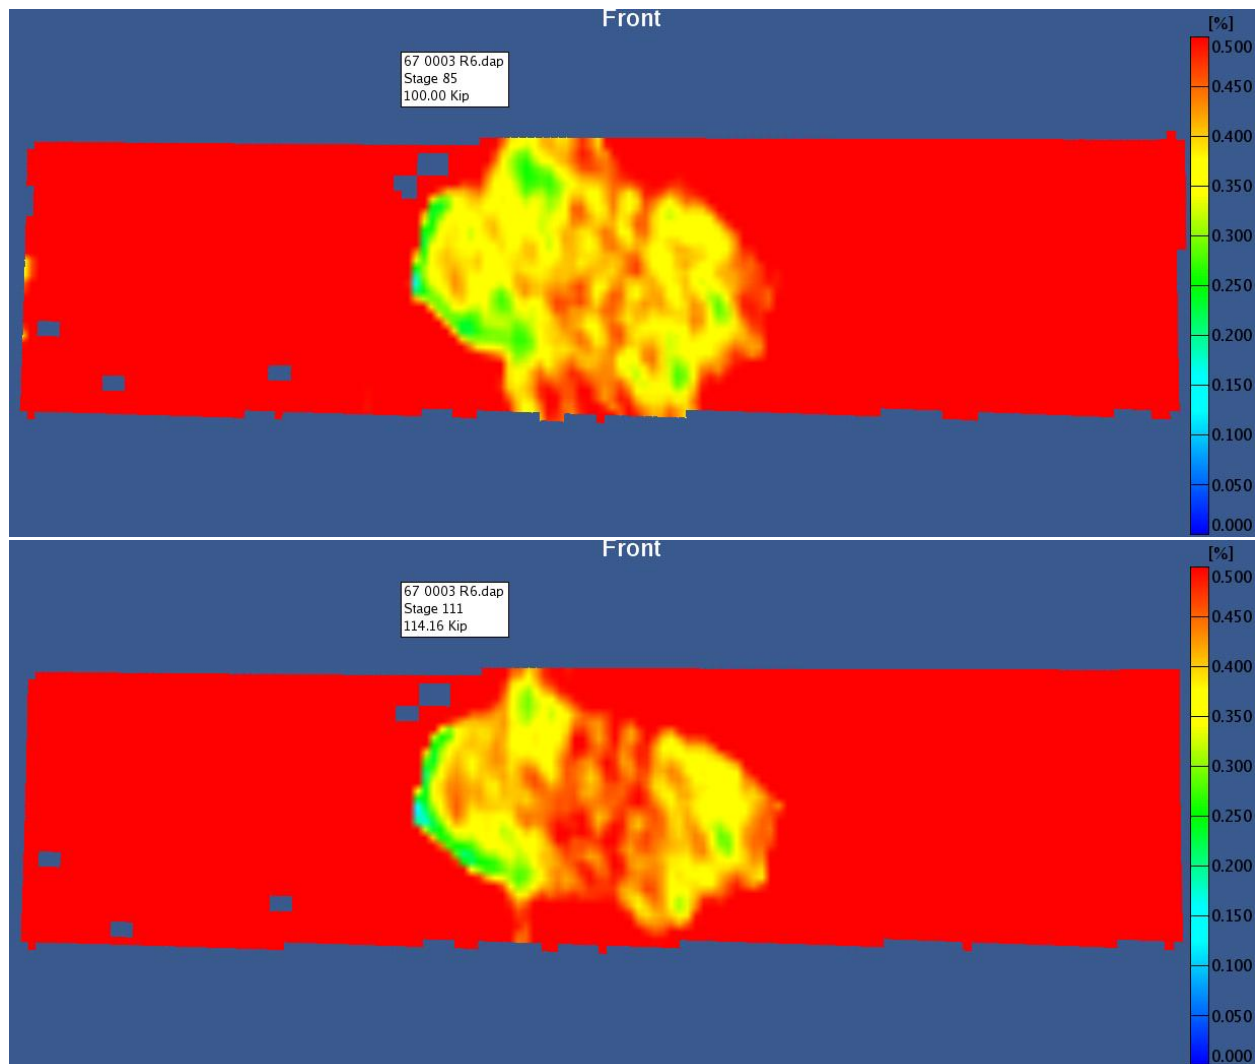
Repair number 67-0003 R 6 had a clipped edge, angled OML patch (CTI repair) that began to delaminate at central tip of the patch at approximately 75 ksi. The delamination grew slightly under the patch with increasing load. The specimen failed at 79.9 ksi. Figure 26 shows the strain field of the patch failure at first detectable occurrence as well as the final maximum extent of the delamination, just prior to substrate failure.

**Figure 26. OML Patch Delamination; Repair 67-0003 R 6.**

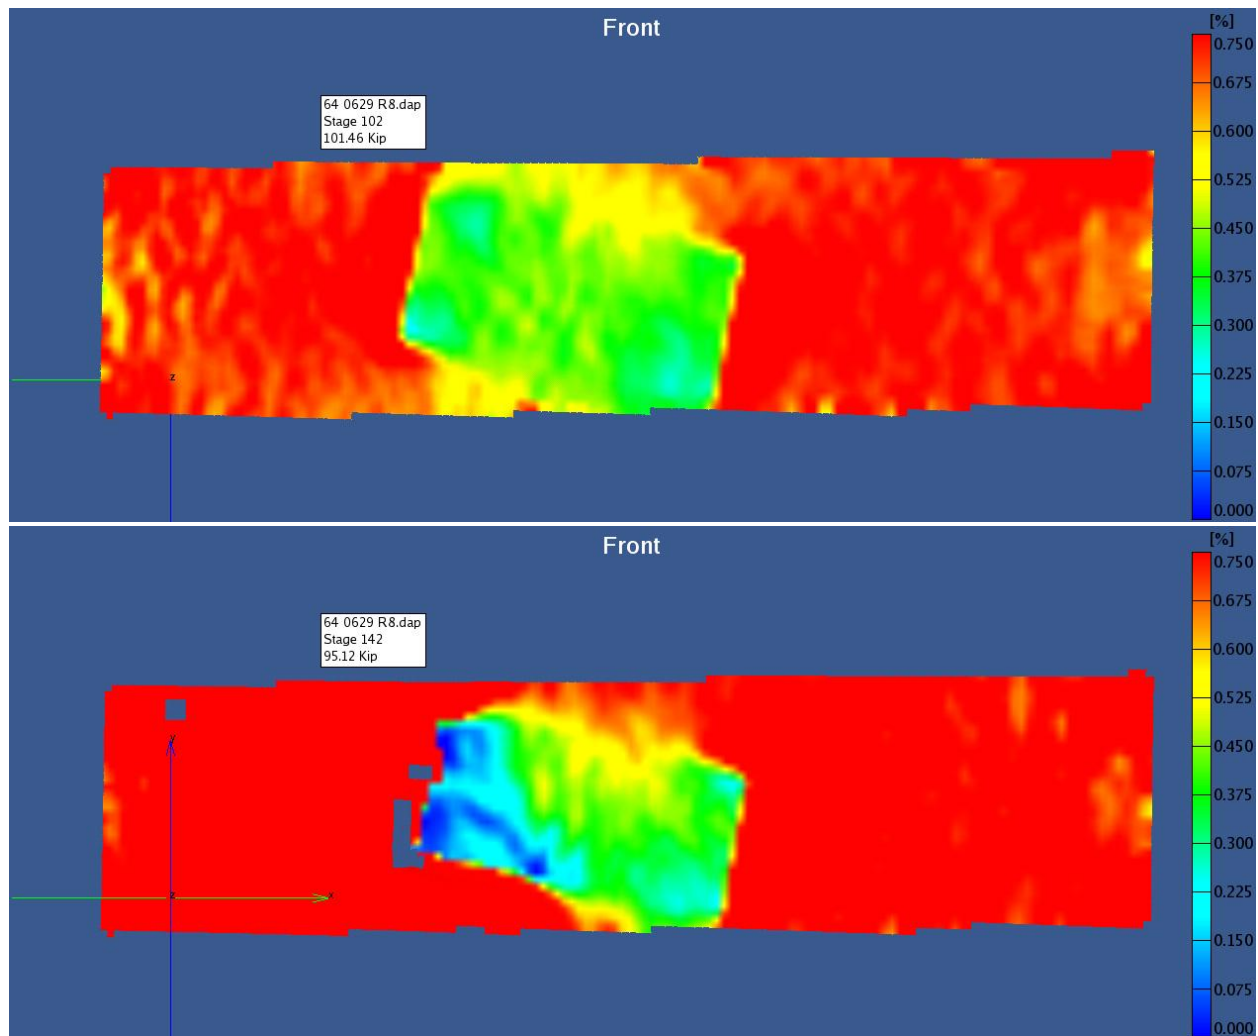
Repair number 64-0629 R 8 had a square edge, angled OML patch (CTI repair) that began to delaminate at central tip of the patch at approximately 73 ksi. The delamination grew extensively under the patch with increasing load. The specimen failed at 81.1 ksi. Figure 27 shows the strain field of the patch failure at first detectable occurrence as well as the final maximum extent of the delamination, just prior to substrate failure.

**Figure 27. OML Patch Delamination; Repair 64-0629 R 8.**

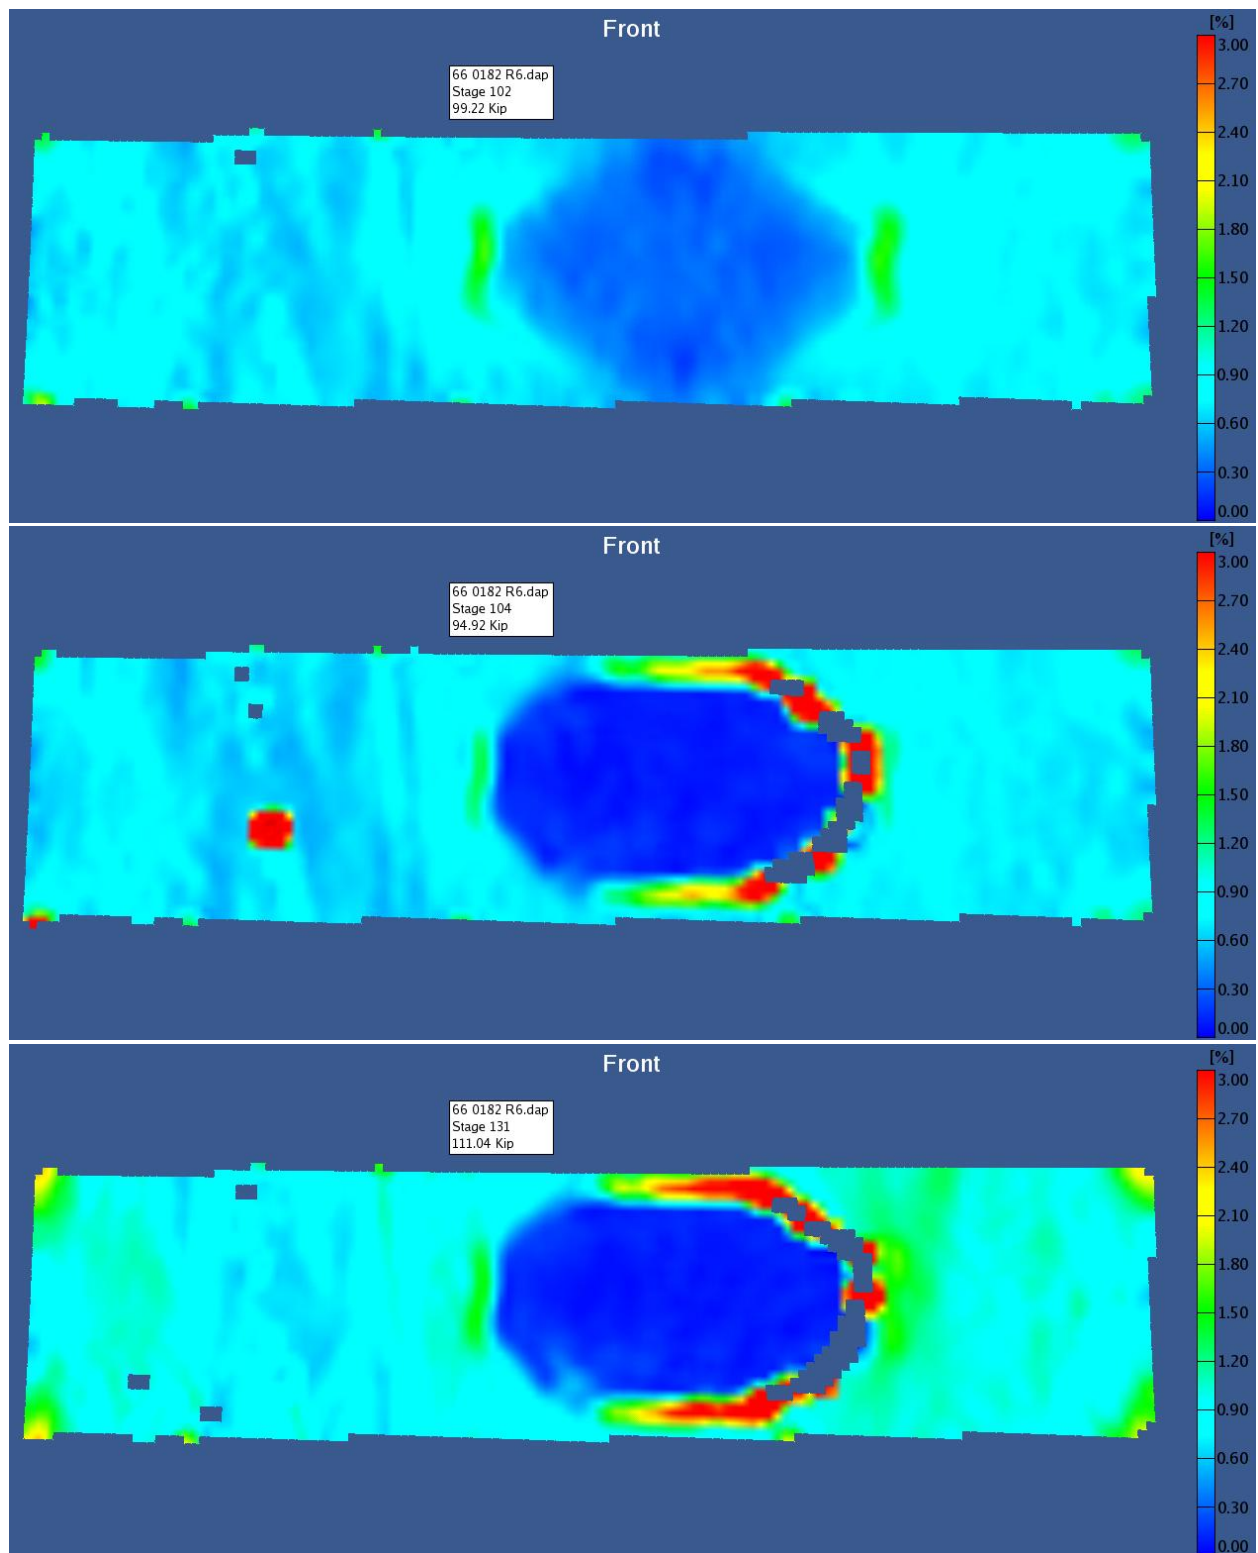
Repair number 66-0182 R 6 had a clipped edge, aligned OML patch (TI repair) that appeared to become disbonded from the substrate at approximately 75.6 ksi. The load dropped simultaneously with the disbond event, indicating that the load carried by the patch was released. The load dropped approximately 5,000 lbs (to a stress of 71.6 ksi). The specimen continued loading from that point to the ultimate stress of 82.8 ksi. Figure 28 shows a progression of SO results displaying the patch strain field just to the disbond event, after the disbond event, and at the ultimate load of the specimen. Note the patch is “cold” after the disbond event, indicating little to no strain being carried through the patch. The area to the right of the patch appears to be at high strain, but this is actually a large crack in the sealant that the SO system incorrectly interpreted as high strain (speckles moved far apart). The OML patch became completely disbonded upon substrate failure and separated from the specimen.

Figure 28. OML Patch Failure Disbond: Repair 66-0182 R 6.

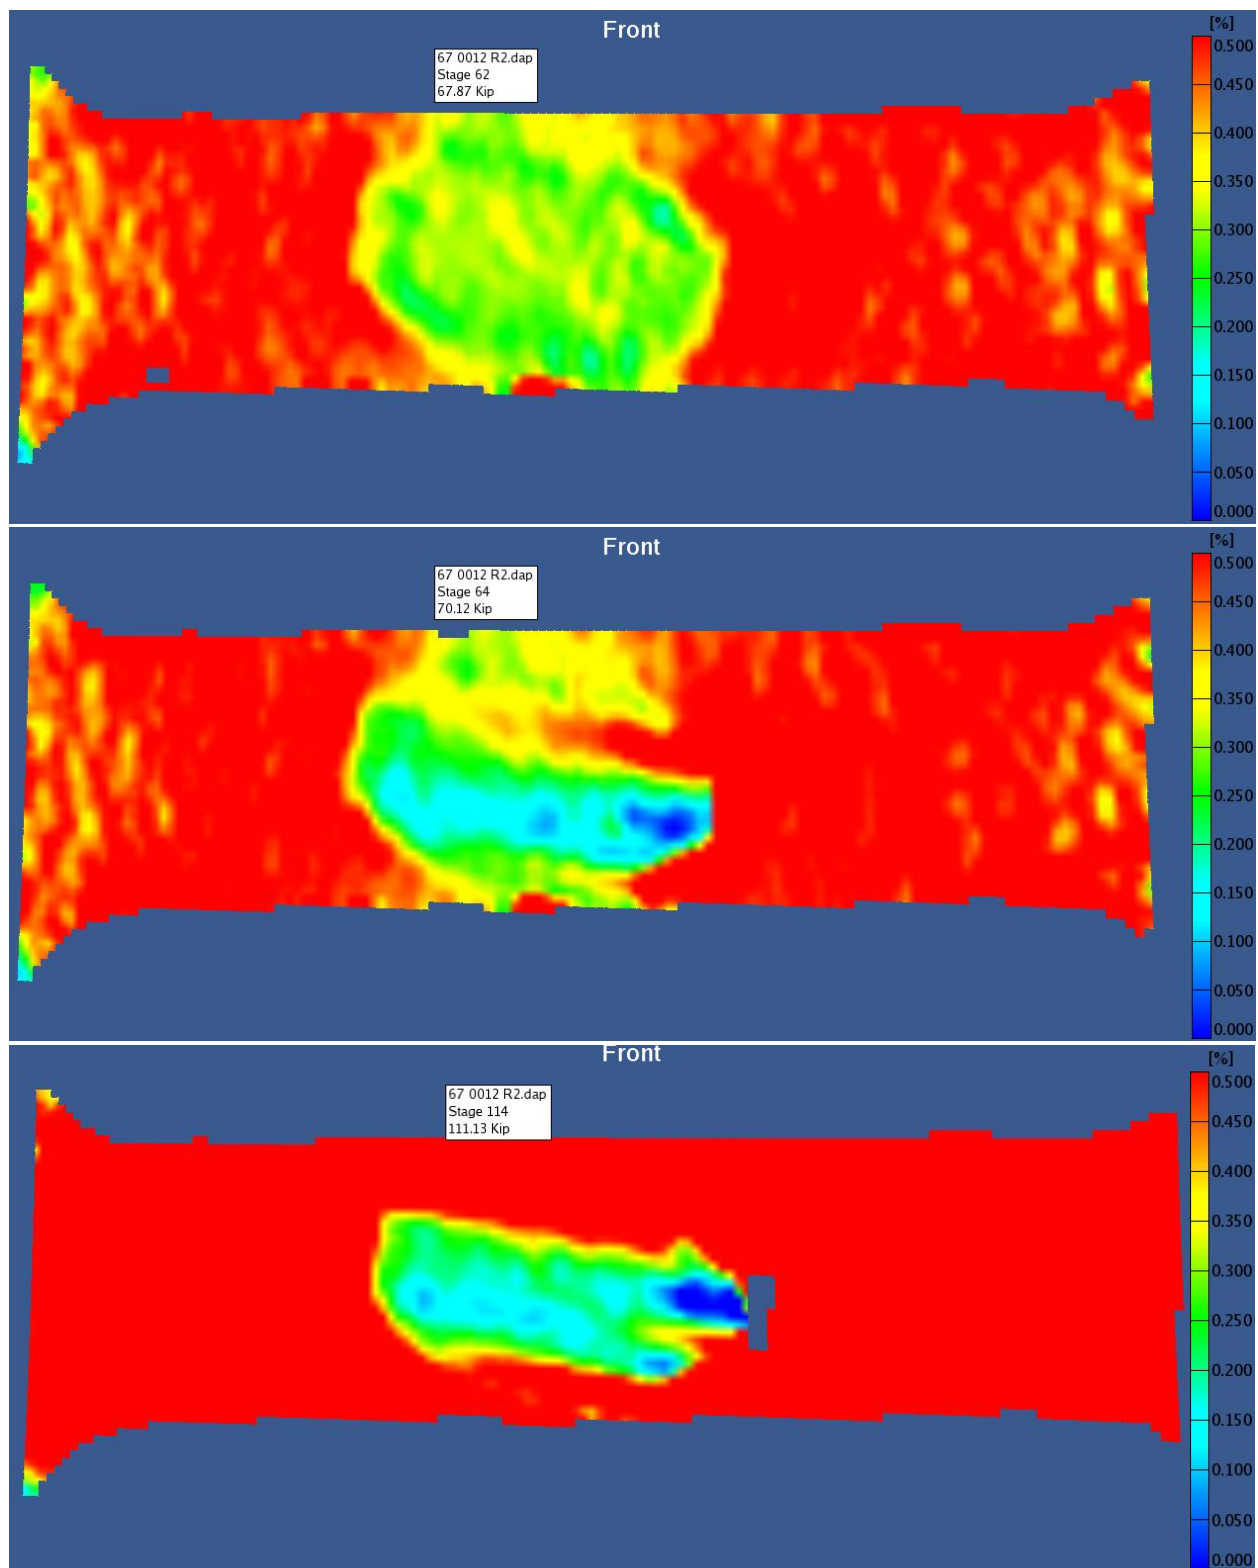
Repair number 67-0012 R 2 had a clipped edge, angled OML patch (CTI repair) that delaminated or disbonded at the lower edge of the patch at approximately 52 ksi. The delamination grew slightly under the patch with increasing load. However, the SO surface strain data surrounding the patch indicated that the patch continued to attract and carry load after the delamination event, indicating that the delamination was in the outermost plies and only affected surface strain. The specimen failed at 83.5 ksi. Figure 29 shows the strain field of the patch just prior to the failure (top), just after the failure at first detectable occurrence (middle), as well as the final maximum extent of the delamination (bottom) just prior to substrate failure. Note that the scale used in the figure has been reduced to more clearly show the patch failure. The specific failure mode of this specimen is further described in reference #AFRL/MLS 06-091.

**Figure 29. OML Patch Failure Delamination: Repair 67-0012 R 2.**

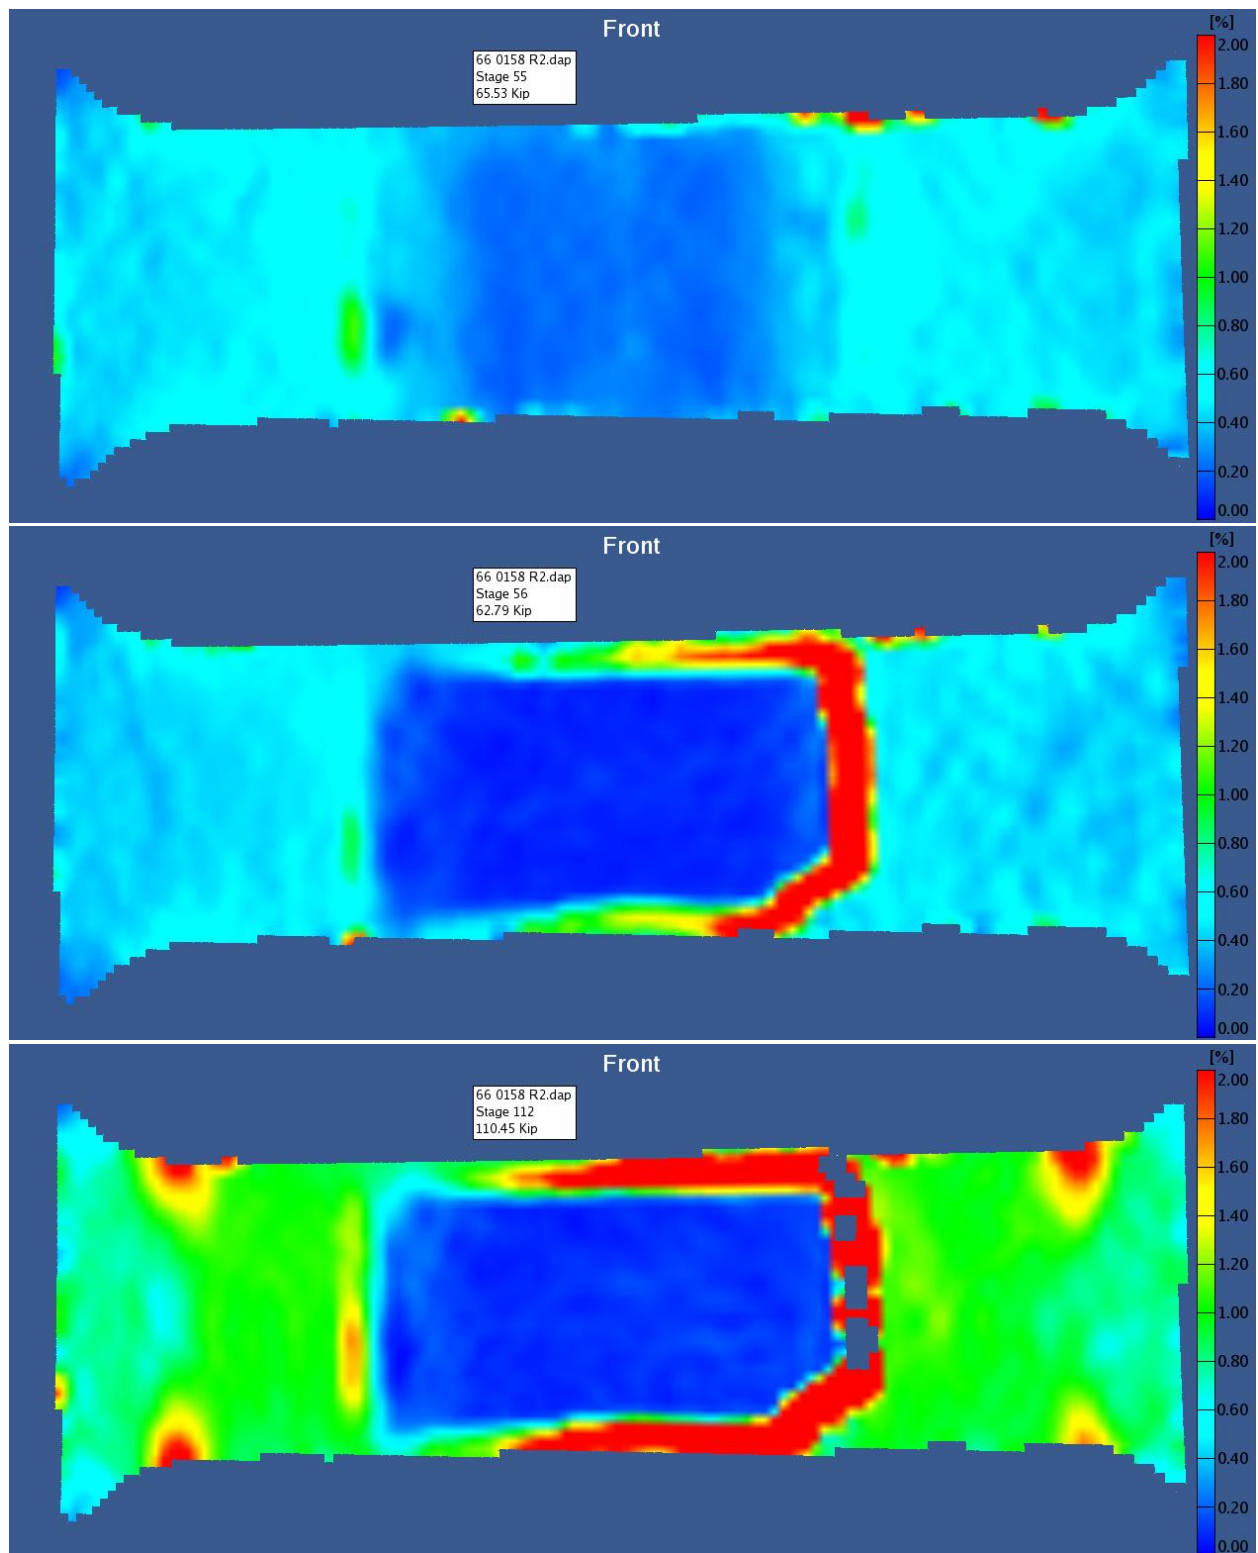
Repair number 66-0158 R 2 had a square edge, aligned OML patch (TI repair) that began to appeared to become disbonded from the substrate at approximately 50 ksi. The load dropped simultaneously with the disbond event, indicating that at least some of the load carried by the patch was released. The load dropped approximately 3,800 lbs (to a stress of approximately 47 ksi). The specimen continued loading from that point to the ultimate stress of 84.2 ksi. Figure 30 shows a progression of SO results displaying the patch strain field prior to the disbond event, after the disbond event, and at the ultimate load of the specimen. Note the patch is “cold” after the disbond event, indicating little to no strain being carried through the patch. The area to the right of the patch appears to be at high strain, but this is actually a large crack in the sealant that the SO system is incorrectly interpreting as high strain (speckles displaced farther apart than surrounding speckles). The OML patch became completely disbonded upon substrate failure and separated from the specimen (reference #AFRL/MLS 06-091).

**Figure 30. OML Patch Failure Disbond; Repair 66-0158 R 2.**

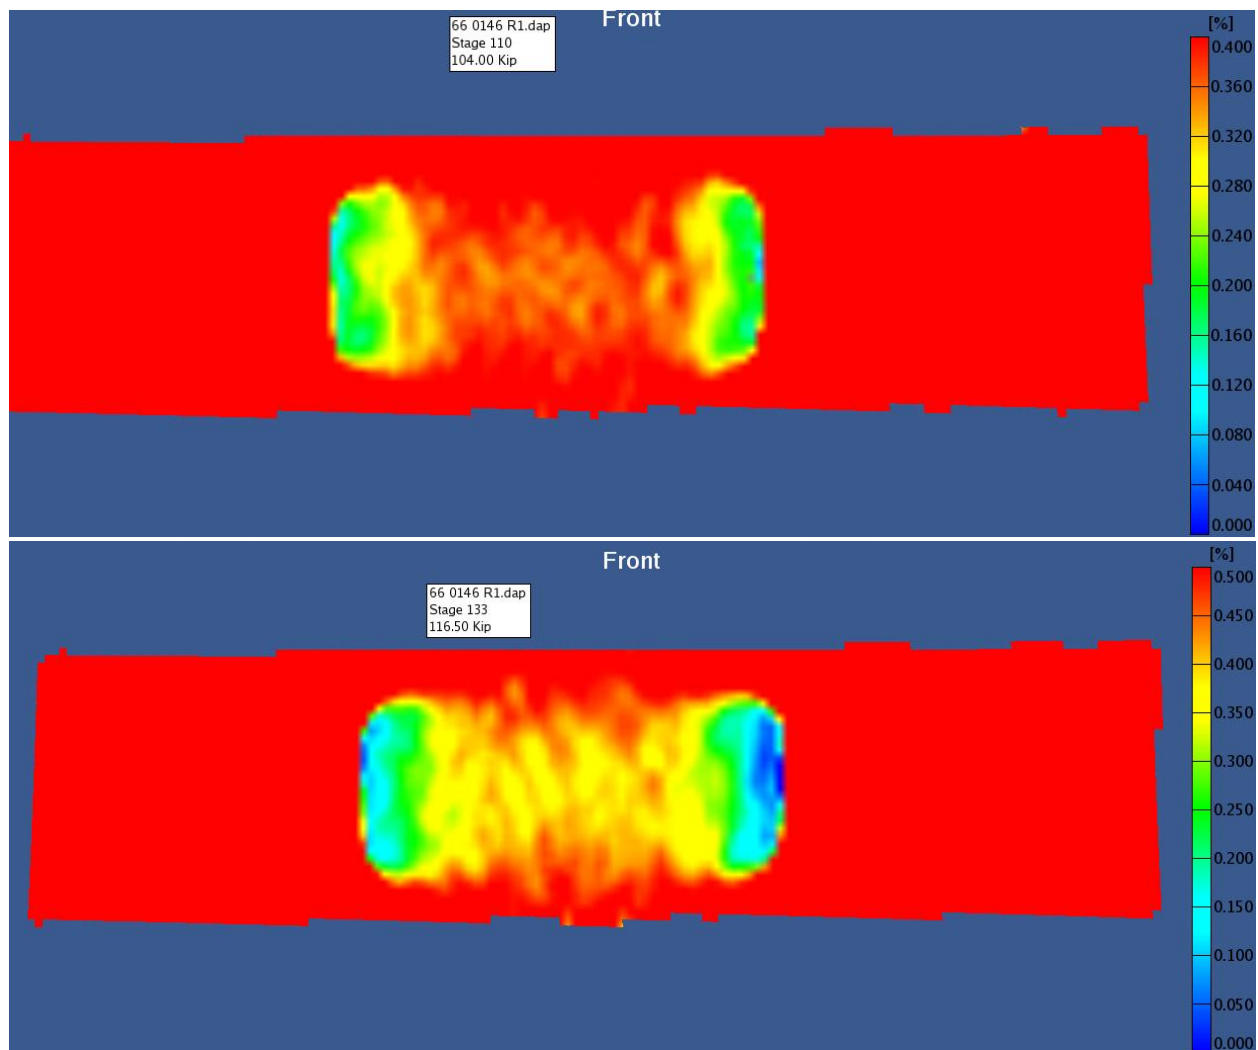
Specimen number 66-0146 R 1 had a square edge (with rounded corners), aligned OML patch (Lockheed repair) that began to delaminate at both edges of the patch at approximately 73 ksi. One of the delaminations grew under the skin of the specimen, parallel to the edge, with increasing load. The specimen failed at 87.2 ksi. Figure 31 shows the strain field of the patch failure at first detectable occurrence as well as the final maximum extent of the delamination, just prior to substrate failure. Note that the scale used in the figure has been reduced to more clearly show the patch failure.

**Figure 31. OML Patch Failure Delamination; Repair 66-0146 R 1.**

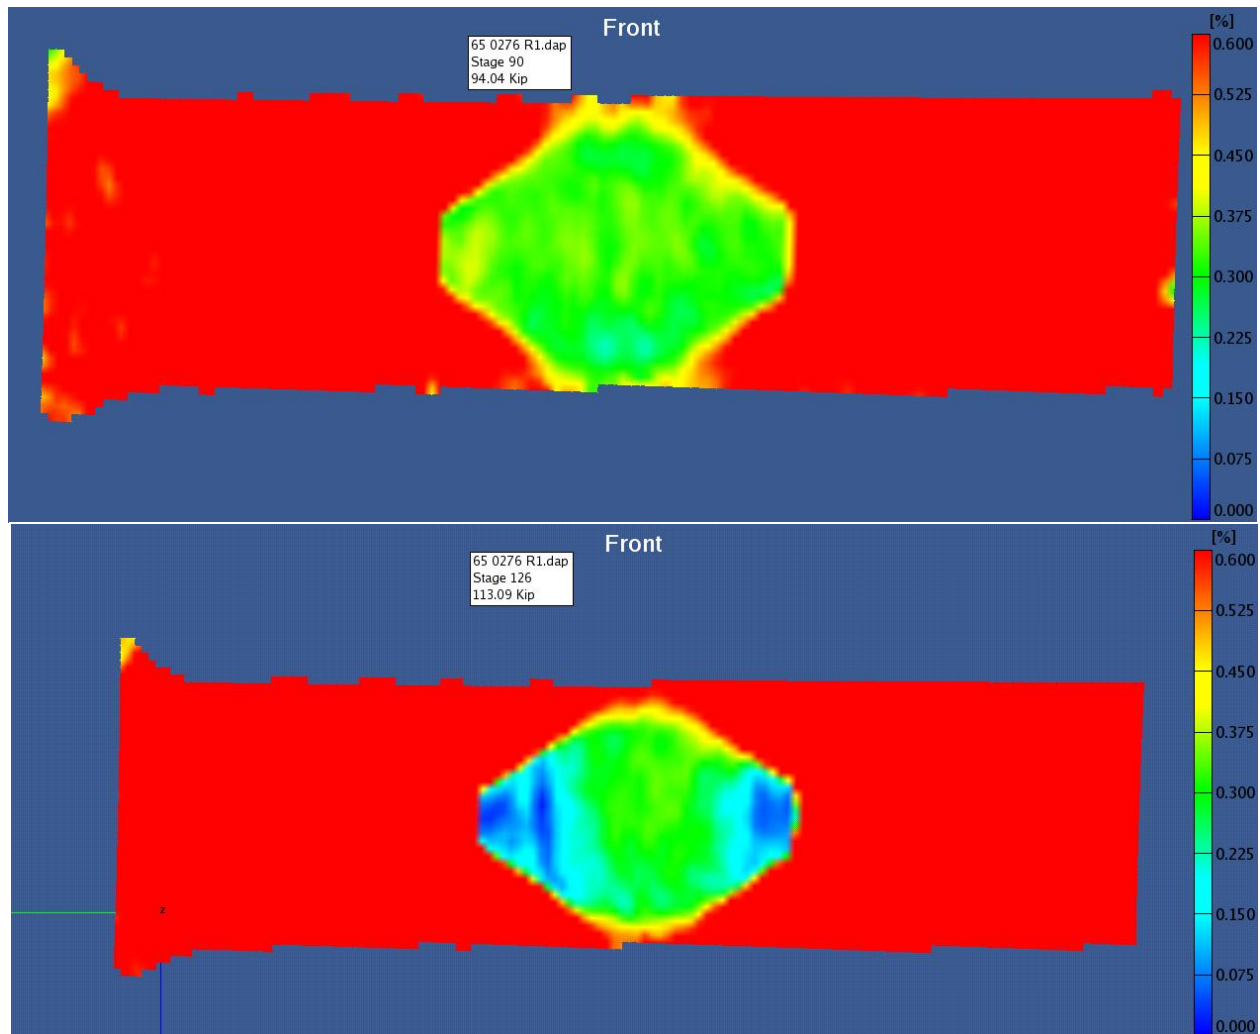
Specimen number 65-0276 R 1 had a clipped edge, aligned OML patch (TI repair) that began to delaminate at both edges of the patch at approximately 77 ksi. One of the delaminations grew under the skin of the specimen, parallel to the edge, with increasing load. The specimen failed at 87.2 ksi. Figure 32 shows the strain field of the patch failure at first detectable occurrence as well as the final maximum extent of the delamination, just prior to substrate failure. Note that the scale used in the figure has been reduced to more clearly show the patch failure.

**Figure 32. OML Patch Failure Delamination; Repair 65-0276 R 1.**
